On Tops Roofing

# Crooked Creek Inspection Report

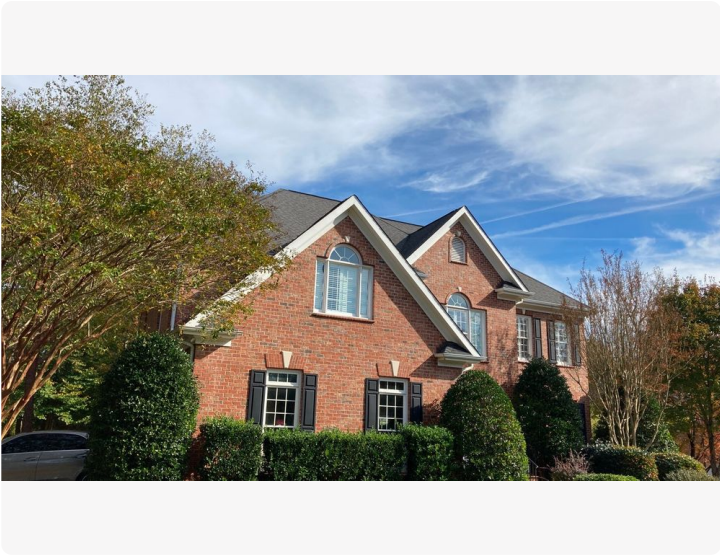
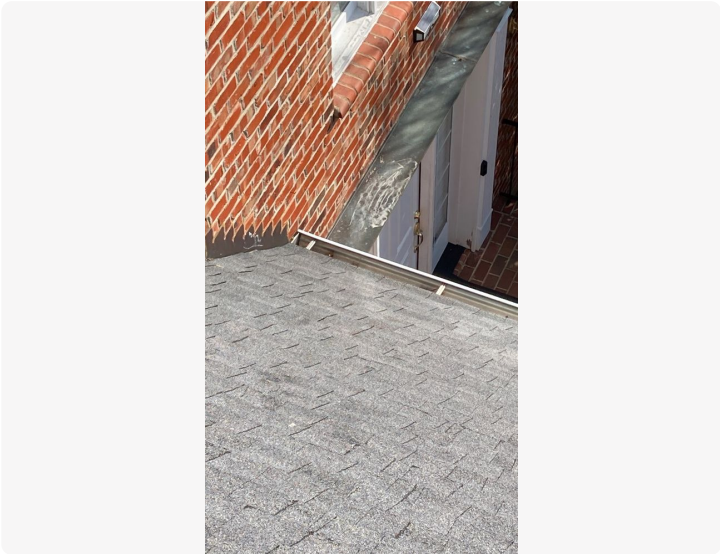
Copper flashing in good condition given its age throughout the roof.

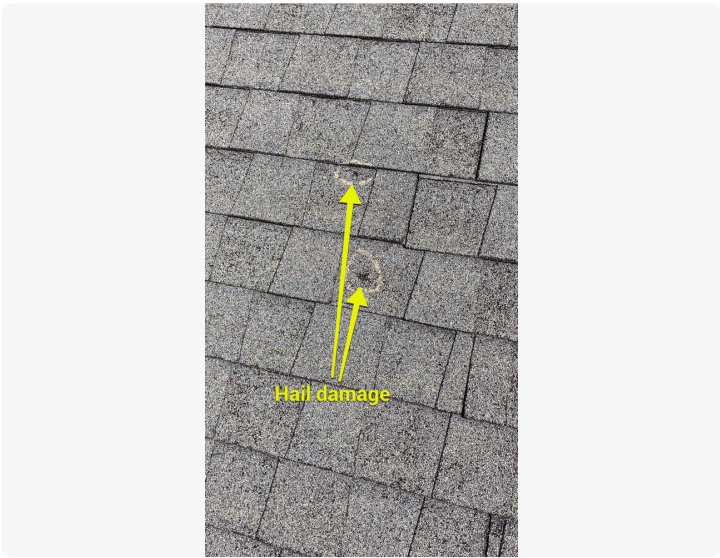
Existing hail damage chalked. Limited hail damage found throughout roof but a new notable hits. These circled ones are down to the fiberglass mat and will shorten the lifespan of the shingles.

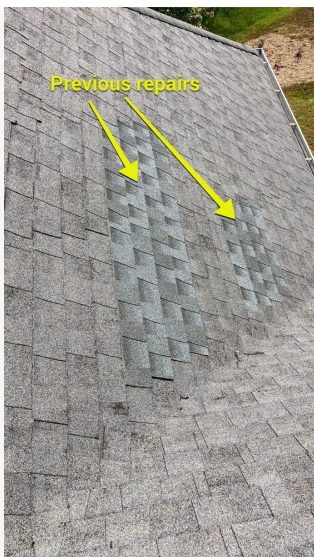
Existing repairs to the north slope of the roof.

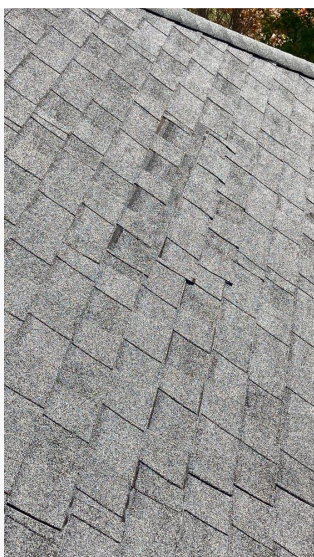
Shingles are sliding down in a couple of areas. This area on the north side has multiple loose or missing shingles.

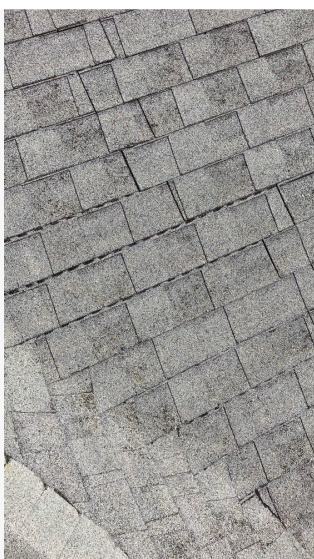
Incorrect shingle exposure present in a few areas. The black lines you can see are the adhesive strip in the nailing zone being exposed. This is a big installation error that reduces the wind resistance of the shingles substantially.

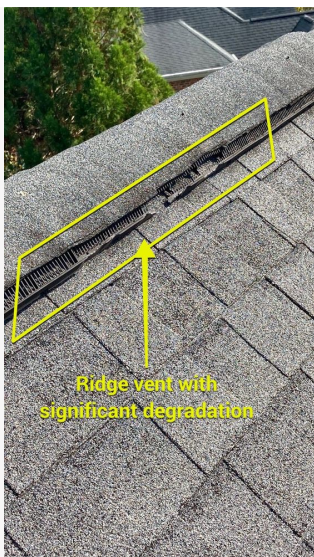
Plastic ridge vent is cracking and deteriorating. This is typically caused by either old age (20+ years) or squirrels chewing on the vent.

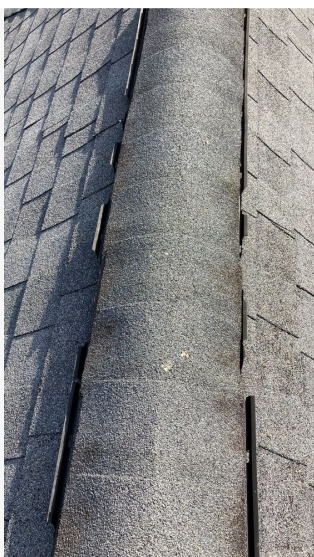
View of damaged ridge vent from above.

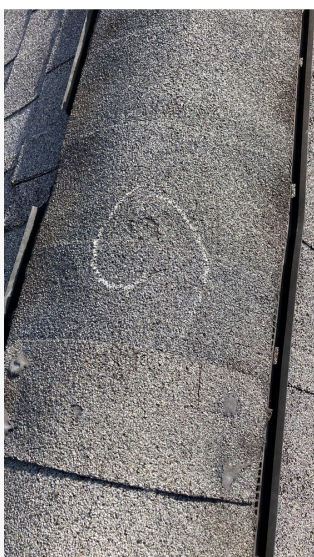
Representative hail hit on the ridge cap shingles.

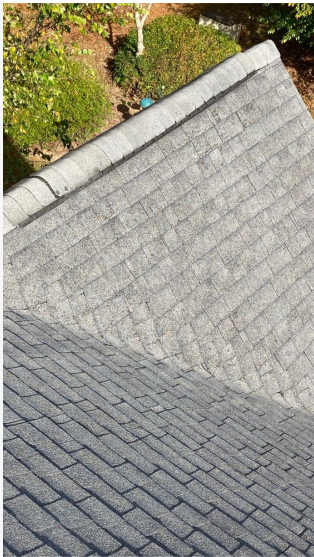
Significant granule loss on most of the roof. This section in particular is starting to get the splotchy look where the fiberglass mat is showing through. The granules protect the shingles from UV damage and when they fall off shingle fail is imminent.

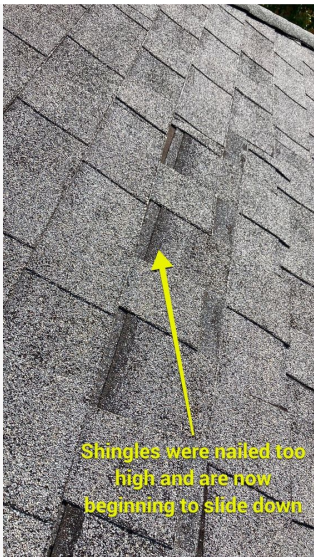
Nailing above the small nailing zone on architectural shingles can result in the layers separating as shown here.

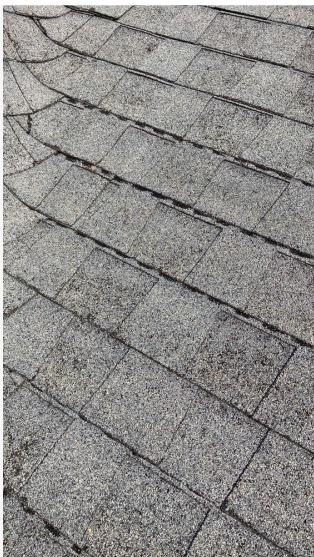
Another view of the valley where the shingles are exposed incorrectly.

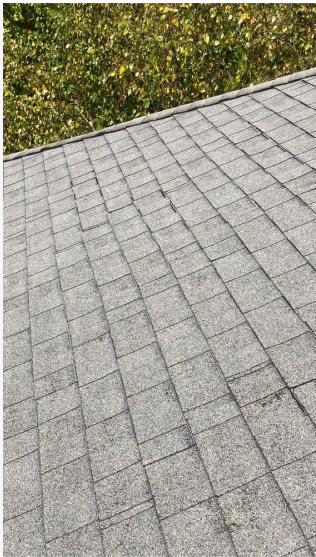
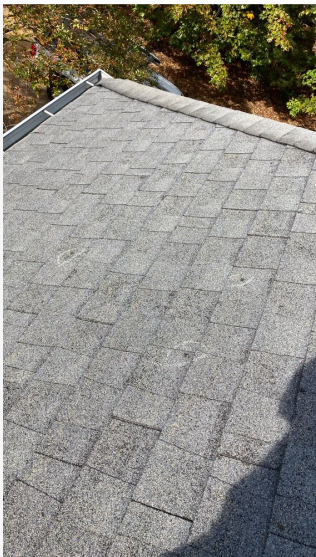
Additional hail hits visible on the south west corner.

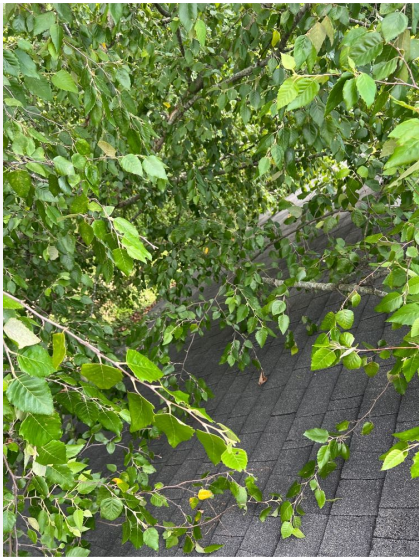
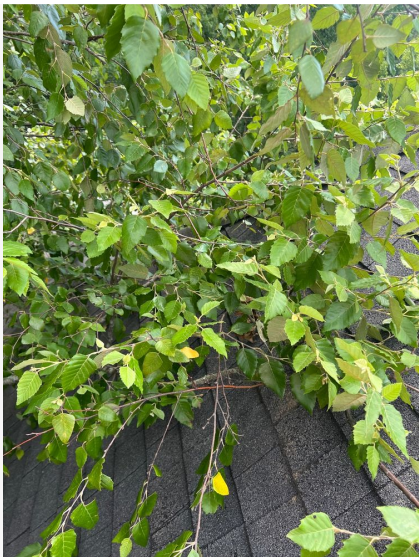
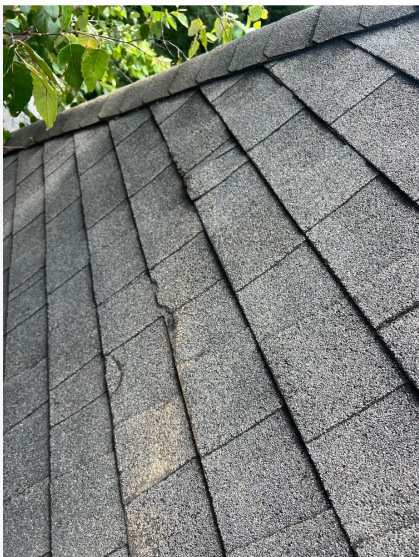
There is some tree damage developing on the east side of the roof above the garage.

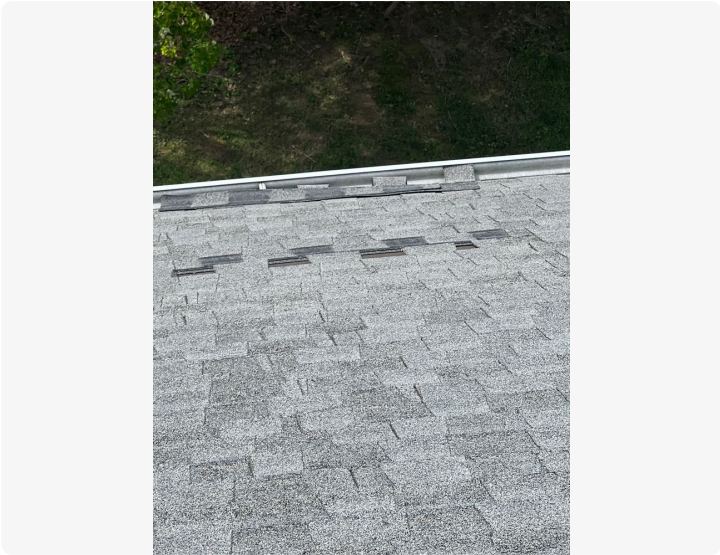
Multiple sections of missing shingles are visible on the rear slope of the roof.

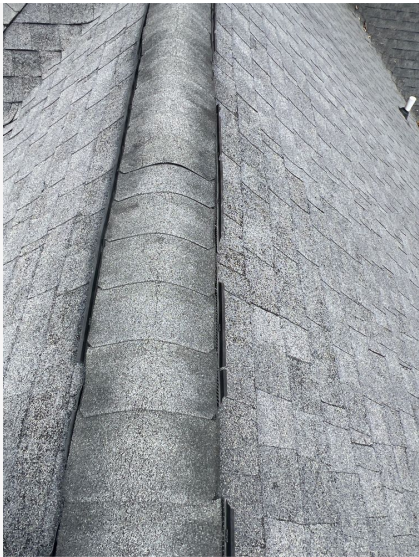
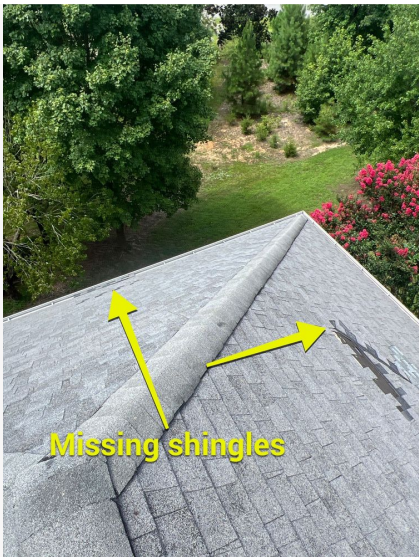
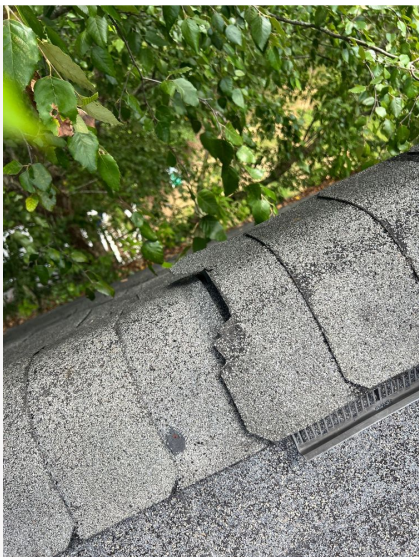
Damage to ridge cap shingles where the ridge vent ends.

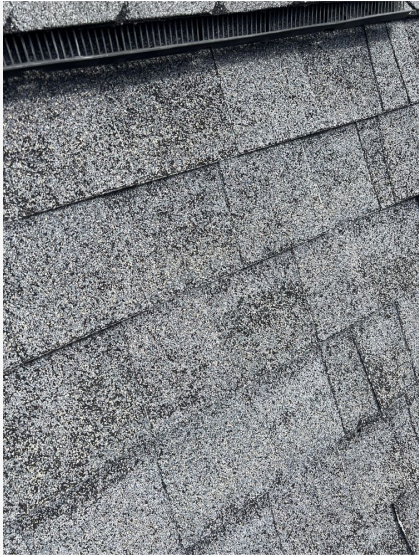
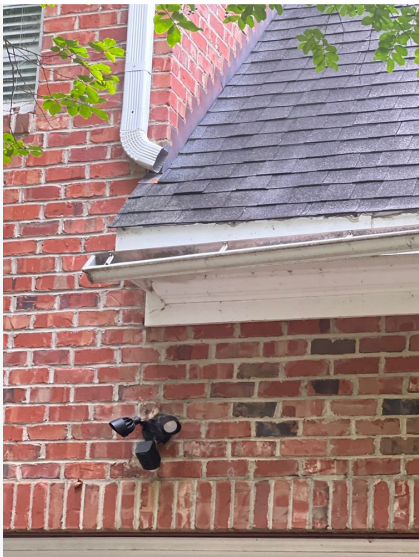
Gutter has become detached from the fascia near the garage. This was likely caused by water damage to the fascia and the weight of the leaves falling in the gutter.

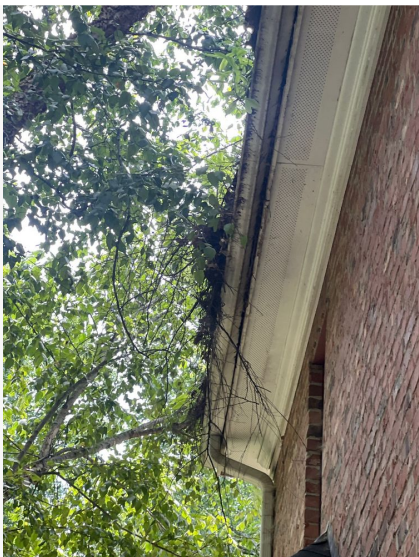
Severely clogged gutters over the garage from the nearby trees.
